**CHARACTERIZATION OF THIN OXIDE DAMAGE
DURING ALUMINUM ETCHING AND PHOTORESIST ASHING PROCESSES***

*by H. Shin, C.-C. King, R. Moazzami, T. Horiuchi** and C. Hu*

University of California at Berkeley
Department of Electrical Engineering and Computer Sciences
and the Electronics Research Laboratory
Berkeley, California 94720

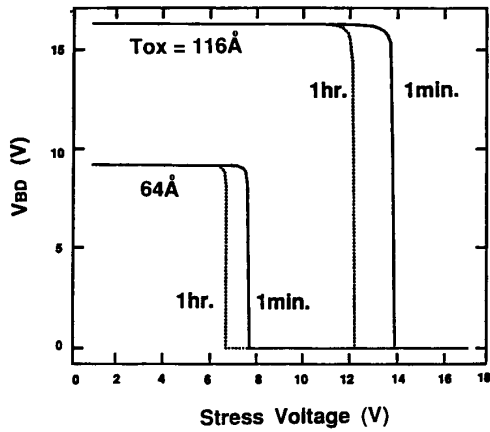
Fig.1. The ramp breakdown voltage after 1 minute or 1 hour electrical stress for oxides of two different thicknesses.

Fig. 1 plots the effect of voltage stressing on the breakdown voltage⁶. Fig. 2 shows the ramp breakdown voltage distribution of large capacitors (1mm²) with 9mm² metal pads after etching and ashing steps. Oxides with initial breakdown voltage less than 10V became shorts after Al etching(B), suggesting that about 7 volts was produced by Al etching⁶. Similarly curve C suggests that about 11

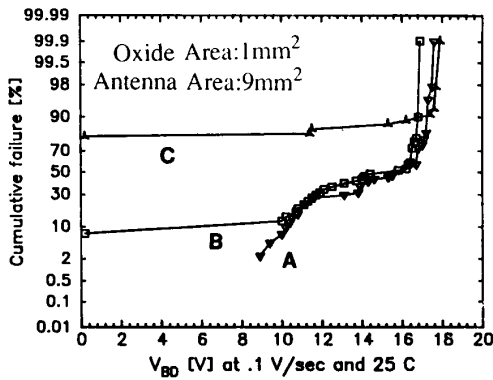
Fig.2. Cumulative failure vs. breakdown voltage for 116Å capacitors with area= 1mm \times 1mm under different processing conditions. A: control wafer, B: plasma Al etching for 100 seconds with power=250 watts, C: condition B + plasma PR ashing for 1 hour.

volts was produced by plasma ashing. The breakdown statistics of intrinsic(very small area) capacitors were measured to investigate the effect of different metal areas to oxide area ratios(antenna effect) and the spatial uniformity of the process induced stress voltage. Fig. 3 shows that there is very little change in the intrinsic breakdown strength for oxides subjected to Al plasma etching only(B). However, plasma ashing causes significant reduction in breakdown strength even for intrinsic oxides. Capacitors with larger metal pads have higher failure

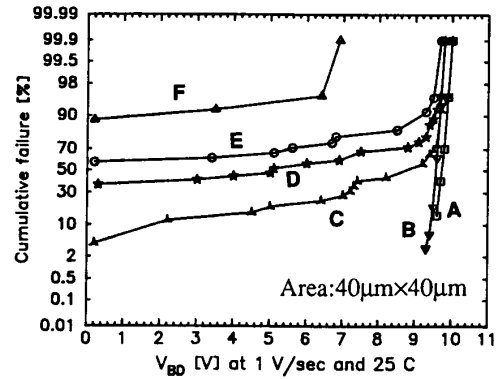
Fig.3. Cumulative failure vs. breakdown voltage for 64Å capacitors with area= 40µm \times 40µm under different processing conditions and ratios of Al area to oxide area (R). A: control wafer, B: plasma Al etching for 100 seconds with power=250 watts, R=300, C: condition B + plasma PR ashing for 1 hour, R=10, D: same as C, R=30, E: same as C, R=50, F: same as C, R=100.

rates as expected. However, the plasma-induced stress voltage varies over that range between less than 5 volts to larger than 8 volts for a given metal to oxide area ratio as extracted from the large variation in breakdown voltage for small area capacitors after processing shown in Fig. 3. This variation has never been reported before. This non-uniformity is fairly random (as opposed to radially distributed, for example), as shown in Fig. 4.

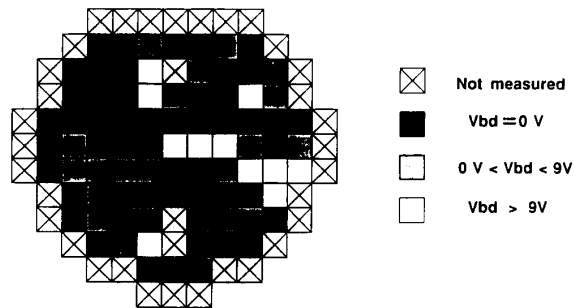
Fig.4. Distribution of breakdown voltage for 64Å capacitors with area= 40µm \times 40µm, R=50, over the wafer.

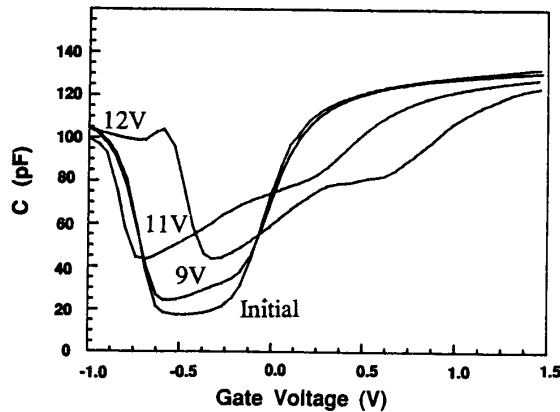
Fig. 5. The quasi-static C-V curves for 116Å capacitors after 1 hour constant voltage stressing.

between Fig. 6 and Fig. 5 confirms that about 11V was produced by photoresist ashing and 7V by Al etching. Also note that the plasma-induced damage during Al etch step is not uniform across the wafer as shown in Fig. 7. More damage is observed near the center of the wafer.

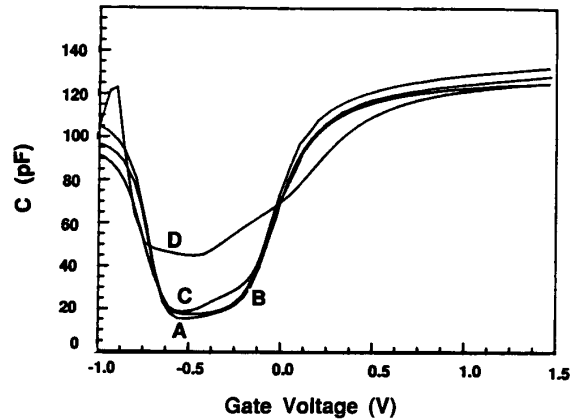
Fig. 6. The quasi-static C-V curves for the same test structure as used in Fig. 2 under different processing conditions. A: control wafer (Al wet-etched), B: plasma Al etching for 100 seconds with power=250 watts, C: plasma Al etching for 60 seconds with power=500 watts, and D: condition B + plasma PR ashing for 1 hour.

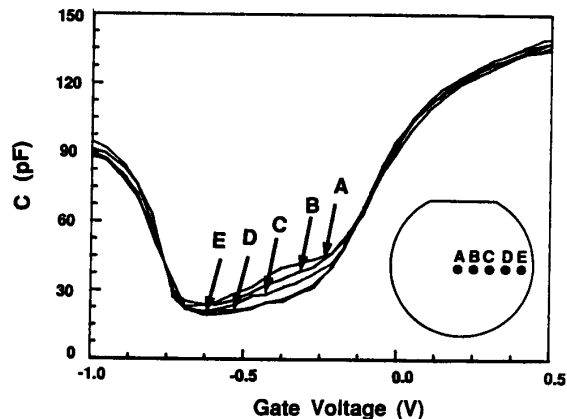
Fig. 7. The quasi-static C-V curves for 116Å capacitors after 60 seconds plasma Al etching for five different positions on a wafer.

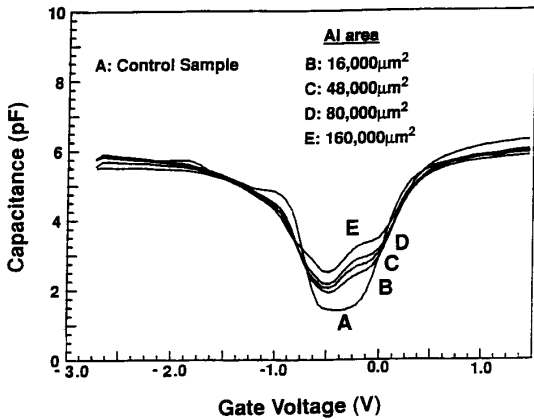
Fig. 8. $1,600\mu\text{m}^2$, 116\AA oxide CV after 60 second plasma etching of Al. Curve A is the CV of wet etched samples.

Fig. 8 shows the quasi-static CV curves for MOS capacitors with different aluminum pad sizes after pad capacitances were subtracted. The size of the capacitors is $1,600\mu\text{m}^2$ with identical layout except for the size of aluminum pads ranges from $16,000$ to $160,000\mu\text{m}^2$. The CV curve for wet-etched capacitor is also shown as curve A. Because larger aluminum pad collects more charge during the etching, the CV curve of capacitors with larger pads show higher degree of degradation. The differences in breakdown voltage and charge to breakdown between A and E are within the ranges of sample to sample random variations (Fig. 1). Clearly, CV degradation is a more sensitive technique suitable for process monitor and for quantitative study of the charging process.
